# CUCKFIELD PARISH COUNCIL

## ACE Committee Meeting 9<sup>th</sup> July 2020

### ACE008.d - Chapel Visit and Photographs

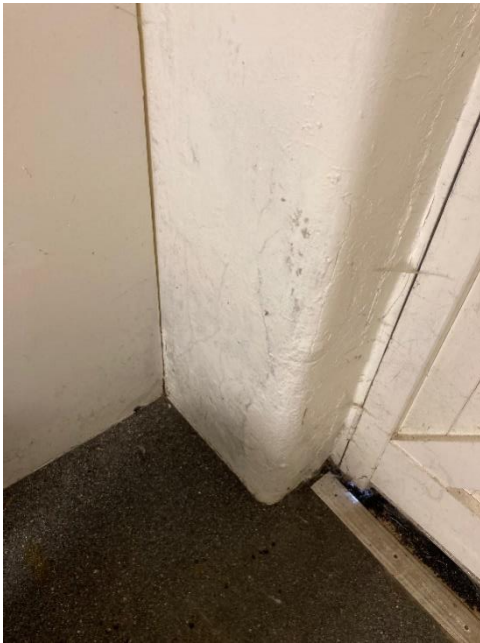
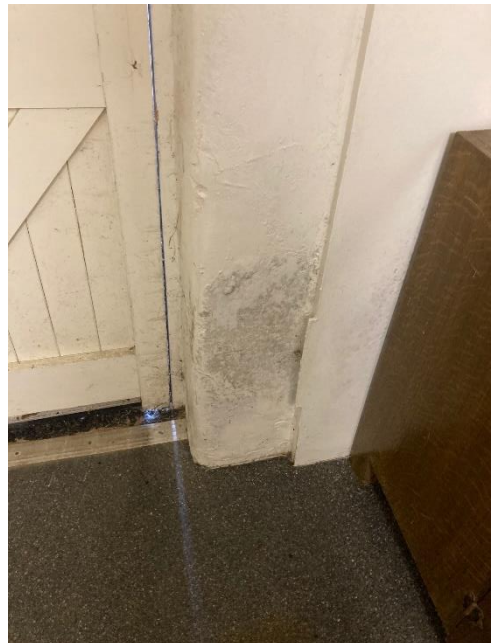
Damp to the internal door frame (left and right sides)

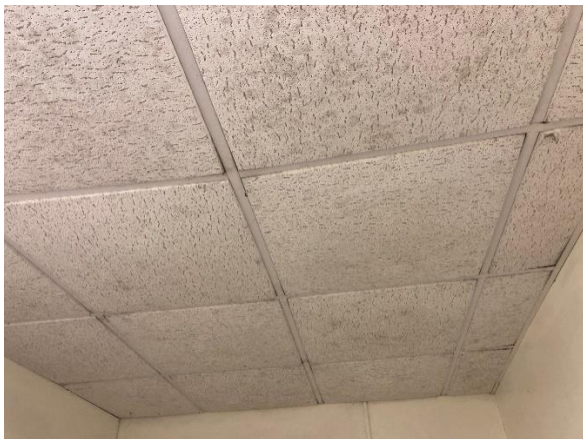
Damp on ceiling tiles.

External wall of the room used for holding the recently deceased. This window cannot be seen from within the room due to the false ceiling. Whether the damp ceiling tiles have been caused by rising damp in a room not frequently used or a leaking roof will require investigation.

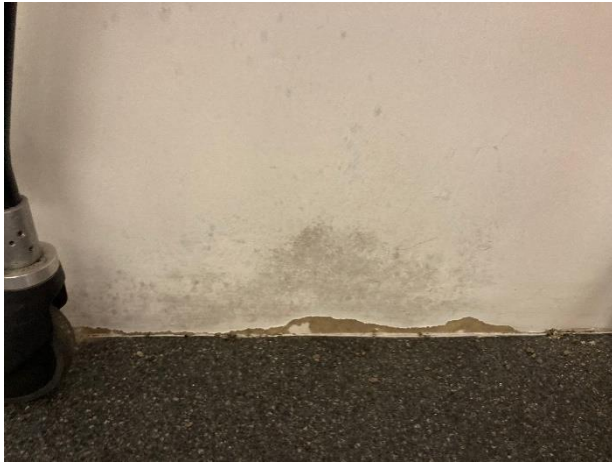
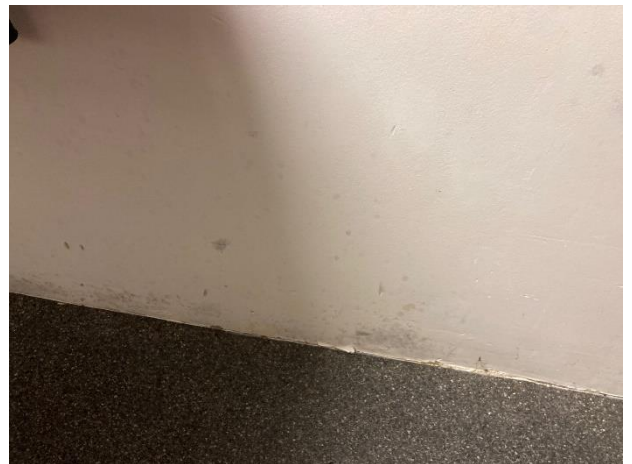
Signs of damp at floor level along external walls.

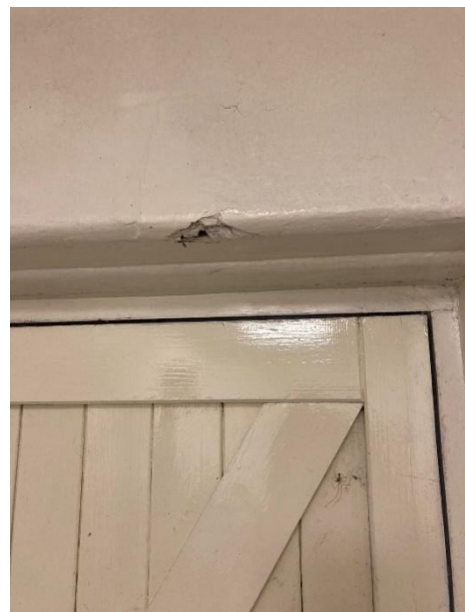
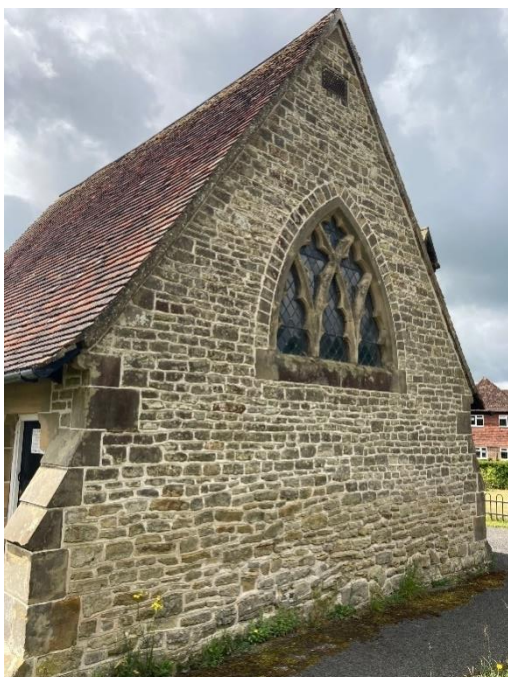
This door leads into the holding room and is where the damp shown around the doorframe above is at its worst.

You can also see the windows (internal shots below) which have been painted out as they form part of the main Chapel of Rest room.

The weeds around the Chapel will be removed by our grounds team.

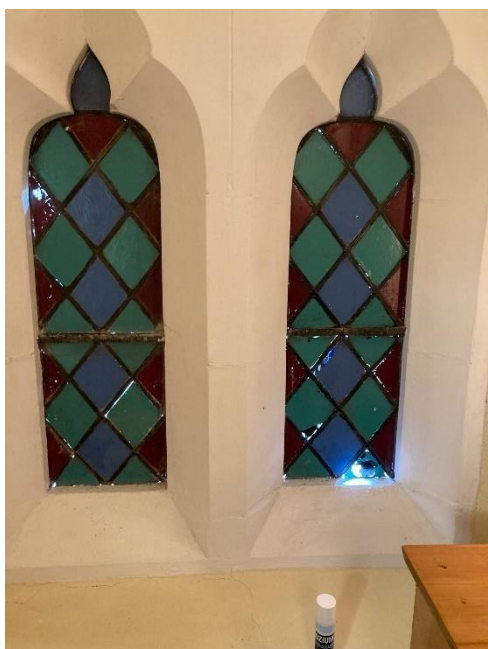
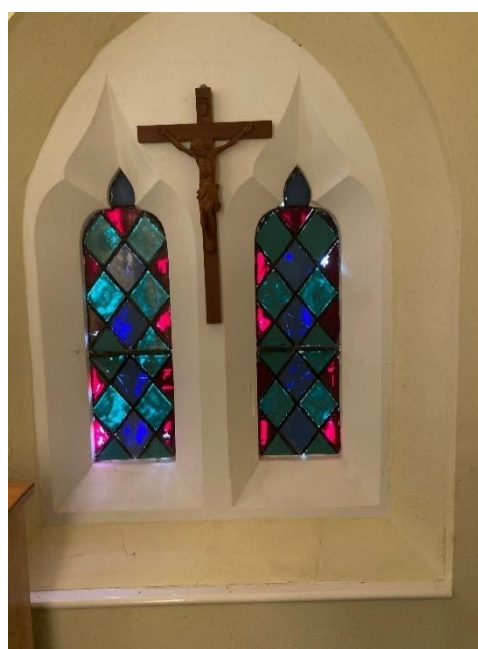
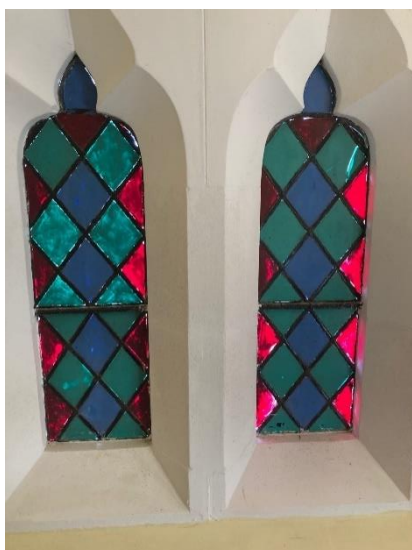
The windows in the Chapel of Rest room have both been painted to stop natural light coming in and people being able to see inside the room from the outside.

Close up to show how windows have been painted.

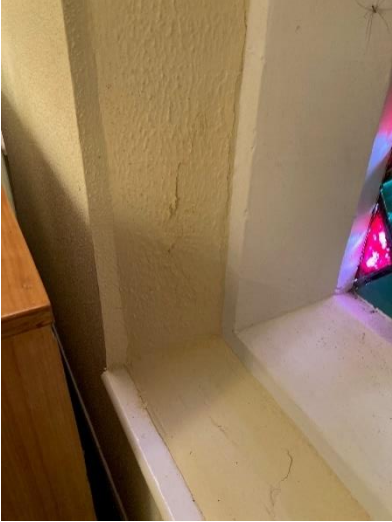
Signs of repair required around both windows, possibly caused by damp plaster.

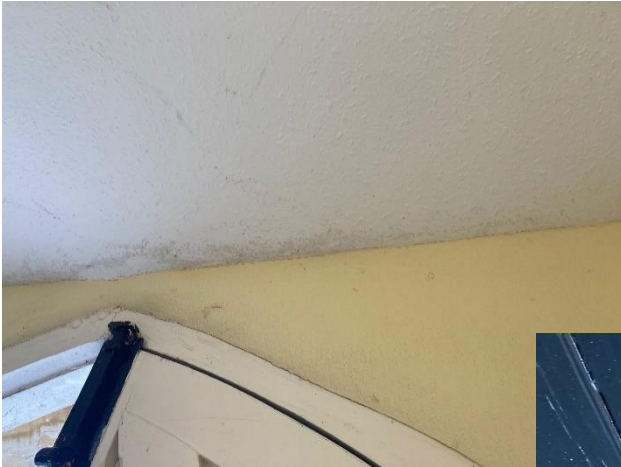
Signs of damp internally above the main doorway, which is also pictured below and requires repair and redecoration.

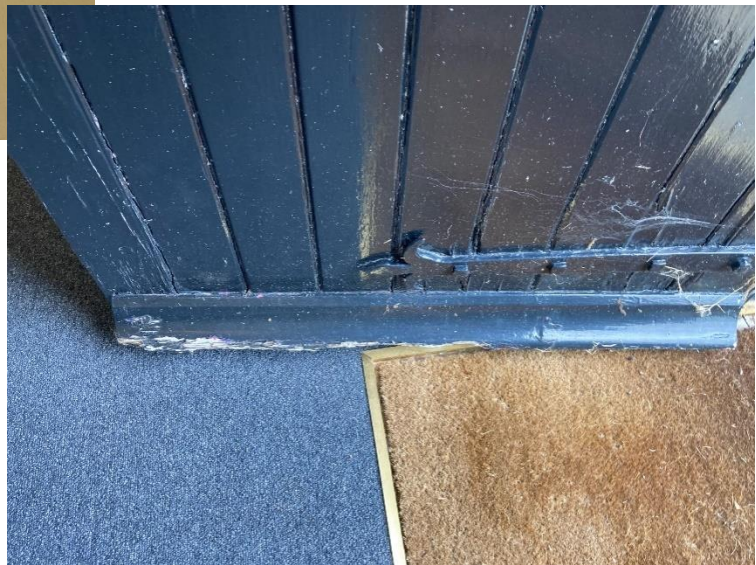
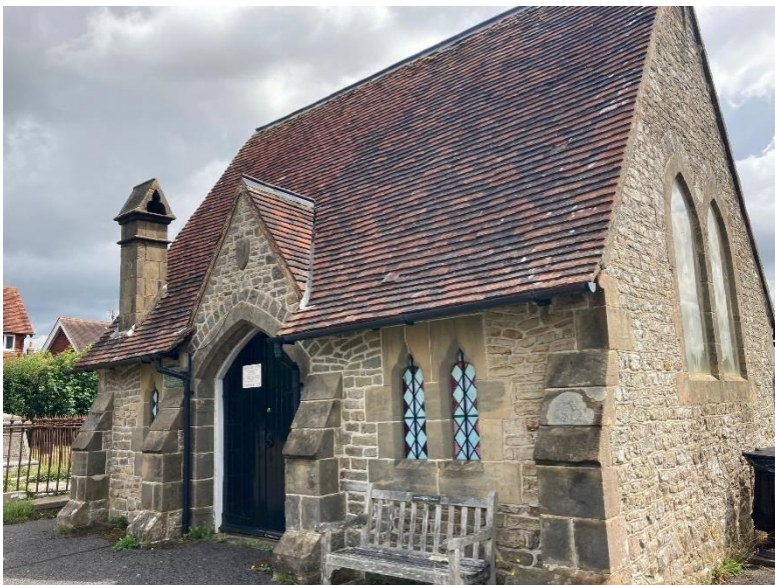
External showing the main entrance to the Chapel. There is a damaged sensor light to the left of the door which requires replacement.
