# Safety Inspection Report

Annual Inspection

## Whitemans Green Skate Park

27 July 2023

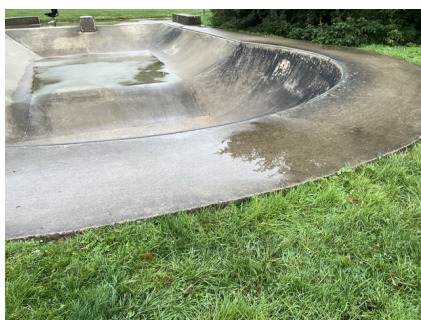
# General Surface - Grass

Trip points on the surface.

Build up surface level to remove trip points.

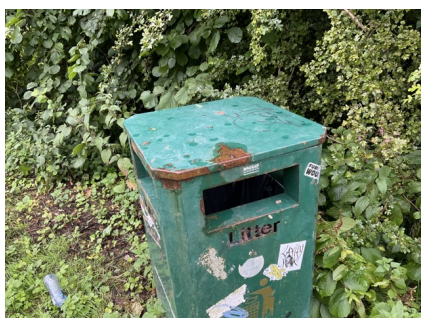
# Litter Bins

Paintwork is in poor condition.

De-scale back to good base material and coat with lead free paint, using appropriate precautions. Repairs may be necessary where corrosion is severe.

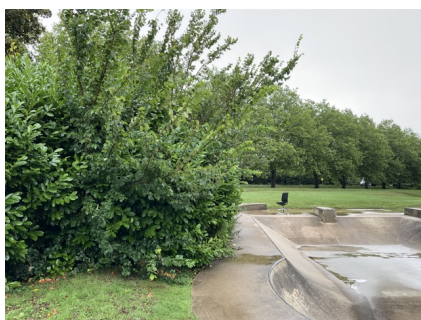
# Planting

Encroaching vegetation or trees.

Remove.

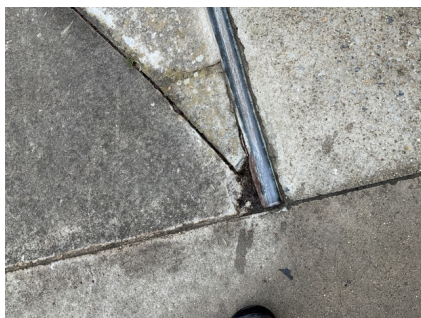
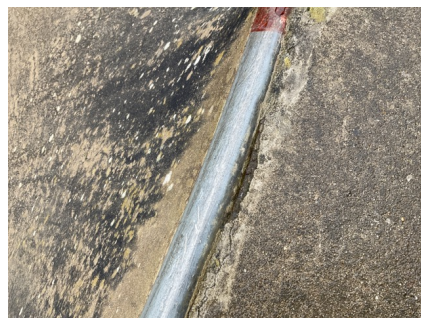
# Skate - Bowl

Concrete edges are in poor condition.

Around outside edge of curved platform and at coping at ramp top.

Repair.

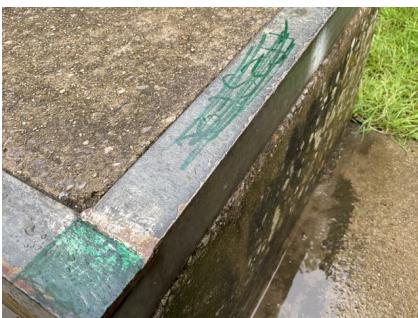
# Skate - Box - Straight Kerb

The item is not compliant with the requirements of the relevant standards. The surfacing meets with the requirements of the relevant standards.

Edges not radiused or chamfered.

No reasonably practicable action is identified.

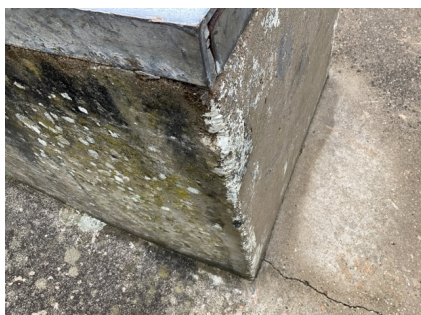
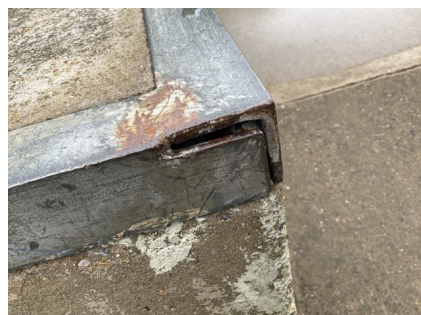
# Skate - Grind Box (Centre)

Item is damaged.

Corners are damaged and metal is opening.

Repair.

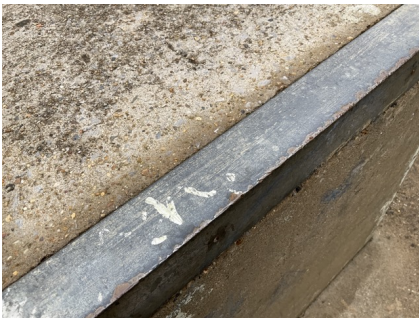
Edges not radiused or chamfered.

No reasonably practicable action is identified.

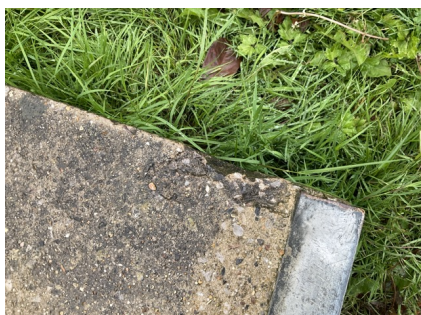
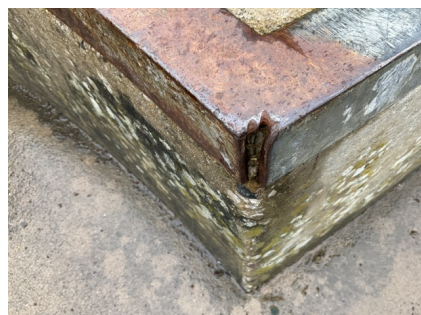
# Skate - Grind Box - Corner

Item is damaged.

Back edge and front lower corners of box.

Repair.

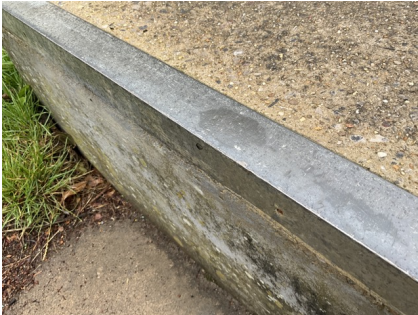
Edges not radiused or chamfered.

No reasonably practicable action is identified.
