## **ASSETS, COMMUNITY and ENVIRONMENT COMMITTEE MEETING 15 OCTOBER 2020**

### **ACE016.d - To receive a report on the churchyard tombs and agree next steps**

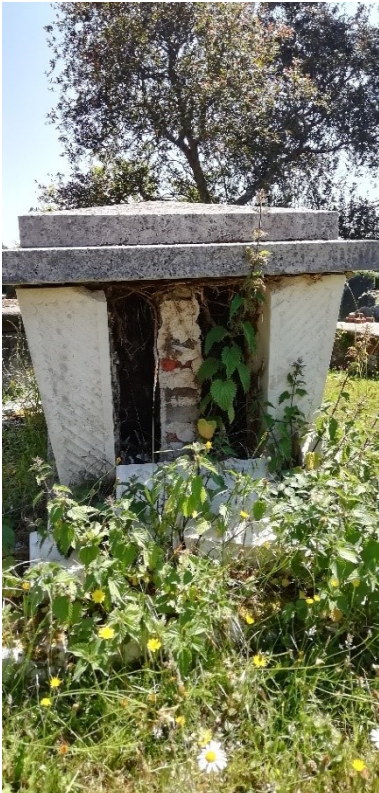
PHOTO 1: MISSING PARTS

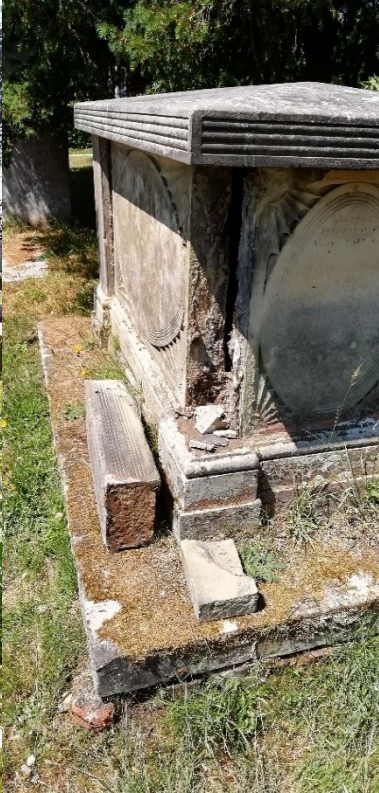
PHOTO 2: BROKEN PARTS

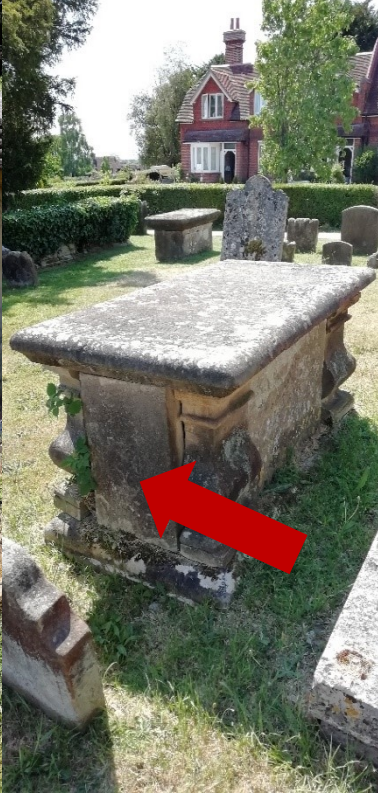
PHOTO 3: LOOSE PANELS

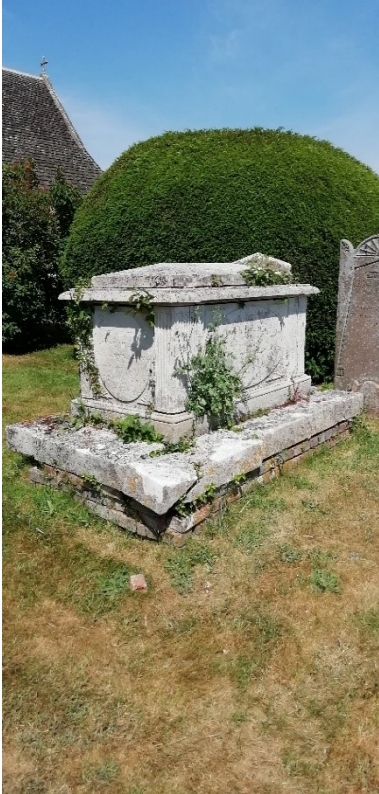
PHOTO 4: BROKEN MASONRY

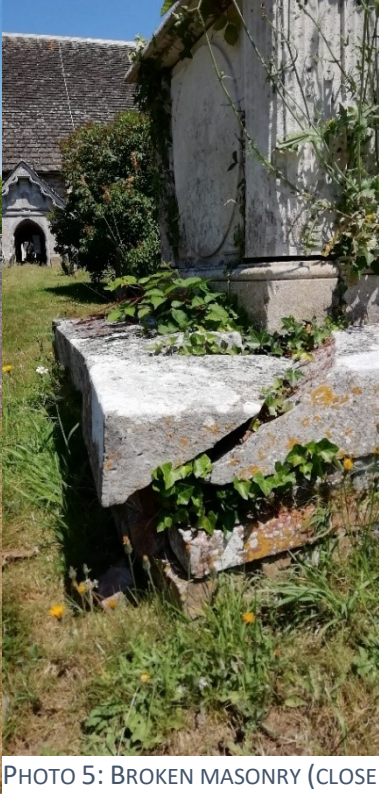
PHOTO 5: BROKEN MASONRY (CLOSE UP)

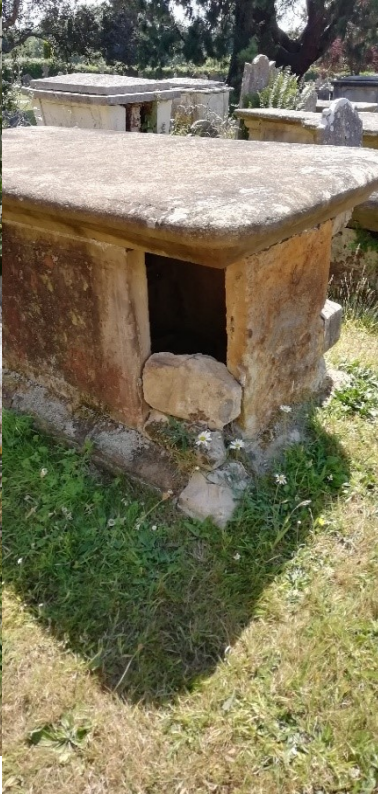
PHOTO 6: MISSING PARTS
