Assets, Community and Environment Committee

ACE12 d): Report on Costs to Repair the Lychgate Slabs

Cuckfield Parish Council Report

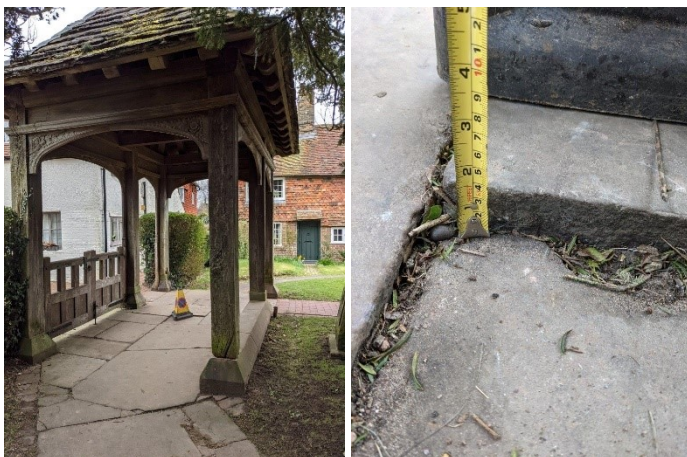
North Lychgate:

For some time now we have been aware of an issue concerning raised slabs in the paved area underneath both lychgates at the churchyard. Each present a potential danger to the public, though the north lychgate (at the end of Church Street) is notably worse than the west.

Regarding the north, he says, *"Further to your recent enquiry I can confirm I have looked at the paving at the North Lychgate and don't believe the entire area requires relaying but it obviously need some adjustment in places."*

As I mentioned previously the one at the west gate is far less pronounced than the one at the north. The four photos [below] show that the west one is well below an inch (around 1.5cm), while the north is significantly deeper (at around 4cm).

It would make good sense to repair both areas – it is safe to assume that although the west lychgate does not currently present as serious a trip hazard as the north, it will deteriorate in due course (see Annex). In the short term, we should at least deal with the more dangerous issue with the north gate.

On this basis, we clearly should adjust the slab at the north lychgate, but it is safe to conclude that for the moment at least there is no *absolute* need to take any action in respect of the west gate, although for peace of mind it would probably make sense to consider putting it right as it is likely to deteriorate over time.

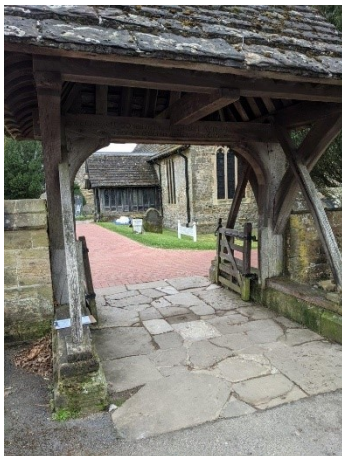
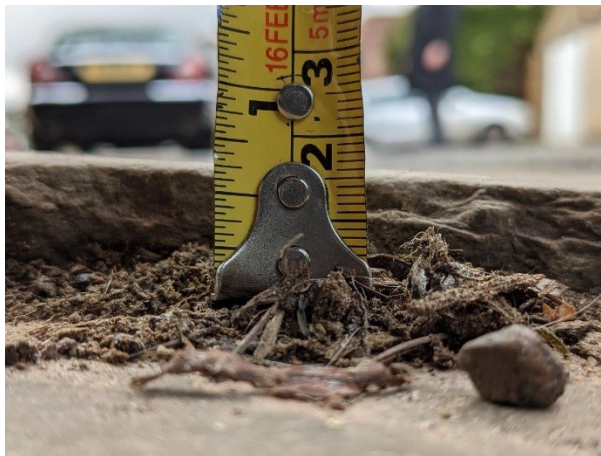
West Lychgate:

For the south: *"I believe the paving at the West Gate would benefit from repointing the joints with sand cement mortar."*
