Ms C Hansen
Queens Hall
High Street
Cuckfield
RH17 5EL

9th October 2019

Re: Damp Report - Queens Hall

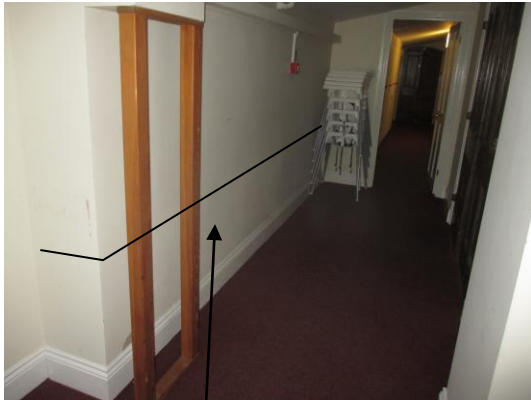
Fig 1

An inspection of the property supported by tests carried out using an electrical moisture meter revealed evidence of dampness in a pattern consistent with the occurrence of rising/penetrating damp.

Area of works

even, after the rising damp has been prevented. Therefore, our operatives to hack off plaster from walls as indicated in Fig 1-3 above. Reinstall using a Titon P2 water proof plastic membrane with integrated mesh for direct plastering
