# Safety Inspection Report

Annual Inspection

## Horsefield Green Development

Cuckfield Parish Council

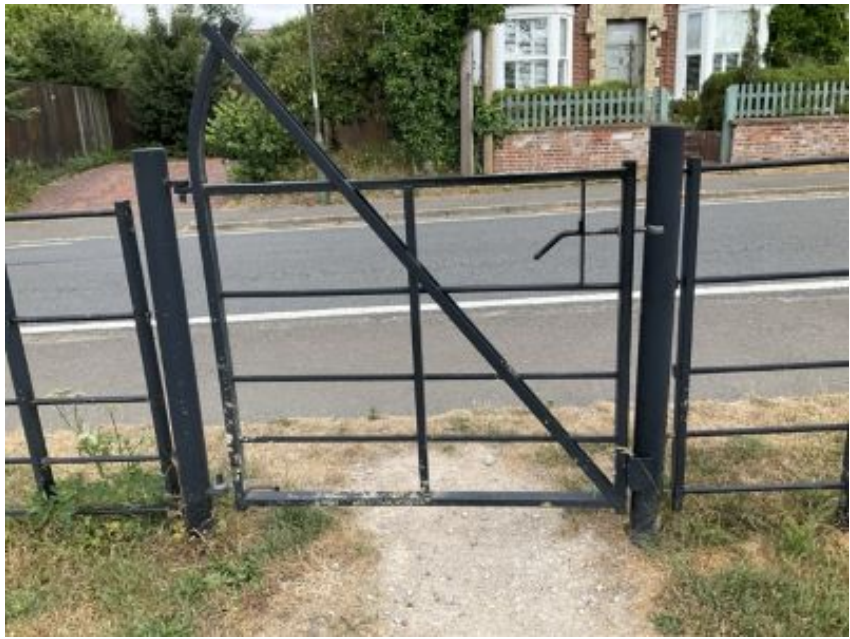
# Gate

| Description | Tasks | Risk score |
|---|---|---|
| There is a crushing or shearing point on the side of the gate. Where the gaps reduce to less than 12 mm these have been known to cause serious, permanent injury to children, especially on the hinge side where the leverage forces are significant. | Read the notes for further action. | 8 |

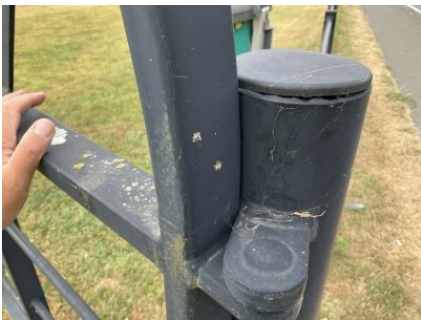
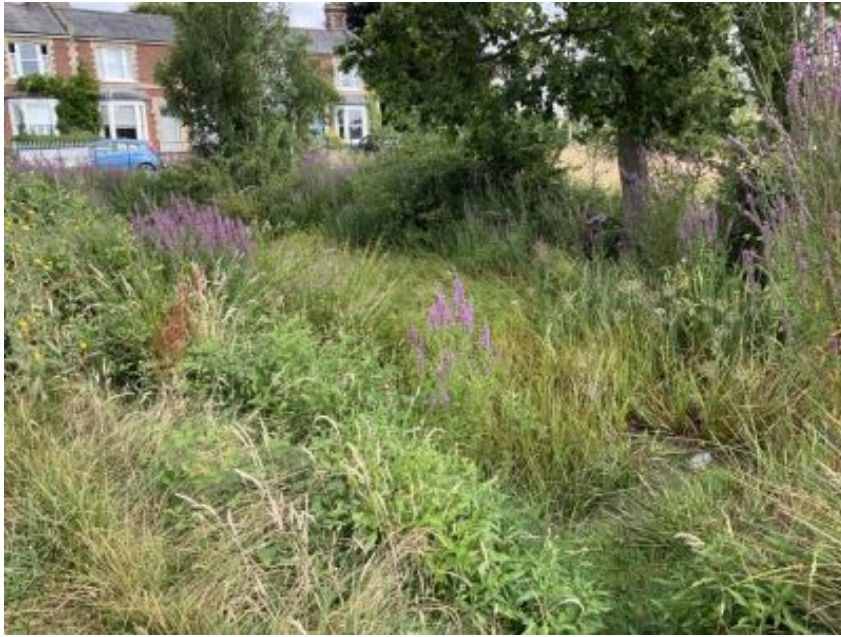
### Finding Photos

There is a crushing or shearing point on the side of the gate. Where the gaps reduce to less than 12 mm these have been known to cause serious, permanent injury to children, especially on the hinge side where the leverage forces are significant.

At hanging post when fully open. Consider fitting stop bar to lower frame.
