# CUCKFIELD PARISH COUNCIL

## ACE Committee Meeting 9<sup>th</sup> July 2020

### ACE008.d - Chapel Visit and Photographs

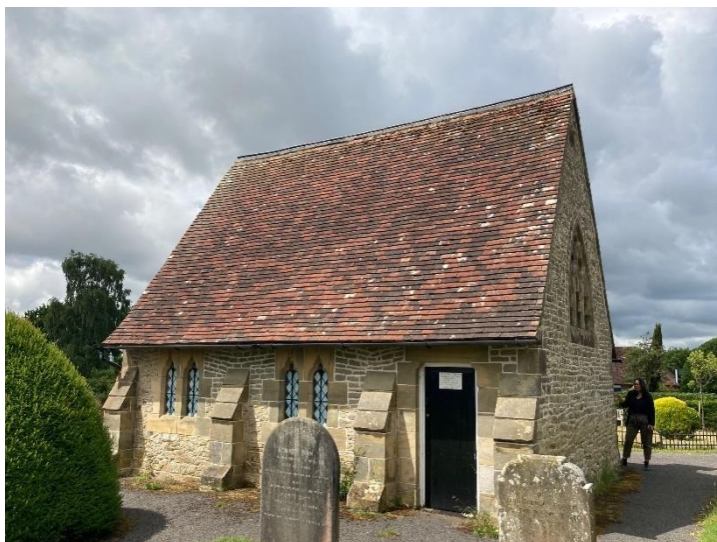
This door leads into the holding room and is where the damp shown around the doorframe above is at its worst.

You can also see the windows (internal shots below) which have been painted out as they form part of the main Chapel of Rest room.
