## **Full Council Meeting 5<sup>th</sup> November 2020**

**FC076: To consider the request from the Parochial Church Council to modify the level of the new north path pavers adjacent to the vestry steps, review the options and associated estimated costs identified and resolve how to proceed**

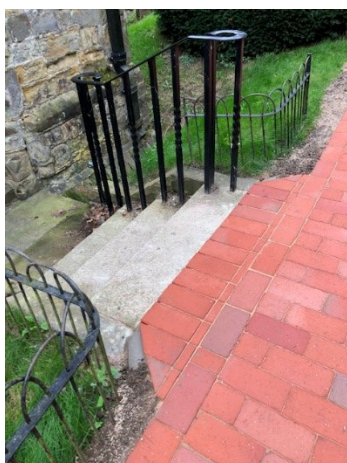
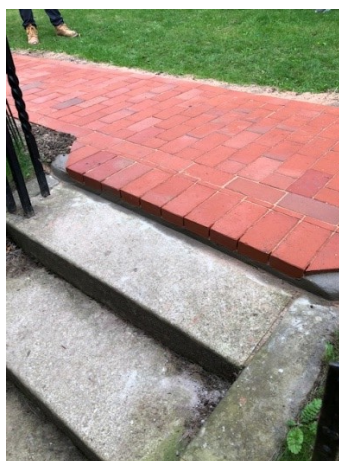
The join between the pathway and the vestry steps was flagged as a concern. However, agreement was reached that a line of red pavers would be installed to highlight the join to the vestry steps as shown in the following images.

The steps leading to the vestry door were rebuilt in 2018, improving their safety by equally spacing and levelling the steps and adding a handrail and lighting. Unfortunately, the new brick churchyard path has been laid on the top of the existing tarmac creating an additional small step which is a trip hazard. This risk will be managed with a warning sign and additional lighting pending discussions with the Parish Council about the possibility of rectifying the problem by lowering the path. At least one person has already tripped ascending the steps.

Option 1 - Lower 21 square meters to level of vestry steps creating a dip in the path;

Option 2 – Completely relay 26 square meters of path to level of vestry steps;

Option 3 – Rebuild vestry steps to include 3 new step lights using left over pavers;

Option 4 - Illuminate the path and steps with additional lighting;

Option 5 – Supply and install an additional reproduction lamp post.

Option 1 would create a risk of water run off towards the Vestry door as lowering this section of path would cause a dip in the path level. Whereas if the whole section of path were re-laid to the lower level it would result in water shed to the grass verges.
